Re: June 2016 Monthly Progress Report

Gasco Sediments Site within the Portland Harbor Superfund Site

# **Visual Observations Log Form**

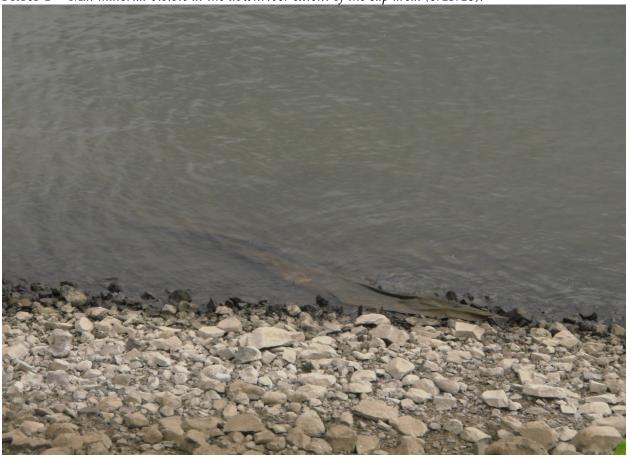
No erosion/deposition was evident along the shoreline. All previously noted organo-clay mat material segments are visible. A segment 5 feet in length, is approximately 1 to 3 feet landward of the water's edge near the lateral mid-point of the cap area. A 10-foot section is shoreward of the water's edge, perpendicular to the shoreline at the upriver boundary of the cap area. A section of organo-clay mat material measuring 40 feet in length is exposed near the downriver extent of the cap at the water's edge (Photo 1).

Photo 1- Mat material visible at the downriver extent of the cap area. (6/13/16):

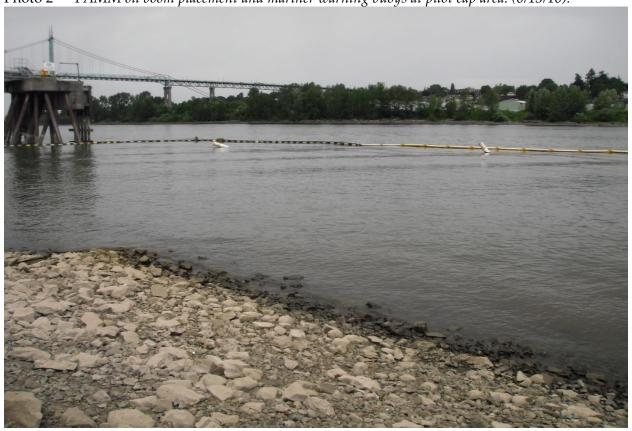
Observations of Long-term Controls (i.e., oil booms, organo-clay mat, etc.) During the observation, the FAMM containment boom was placed across the cap area from the ship dock to an anchor point riverward of the upriver dolphin. Two buoys that identify the cap area to mariners were in place as installed. The position of the FAMM oil boom and warning buoys is shown in Photo 2.

Photo 2 - FAMM oil boom placement and mariner warning buoys at pilot cap area. (6/13/16):

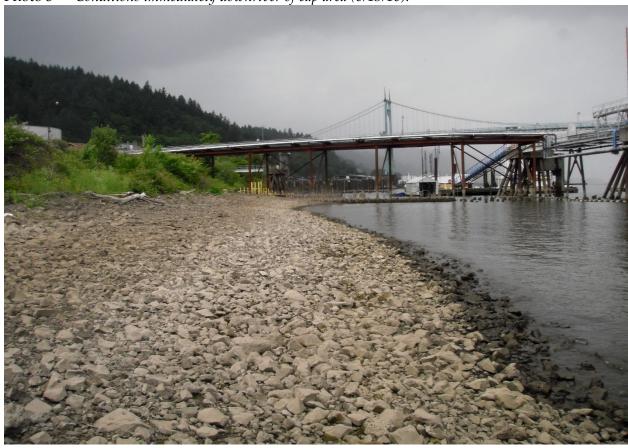
Other Comments:	No sheen was evident in or around the cap area. Photo 3 shows the water surface and shoreline immediately downriver of the sediment cap.
Recorded by:	Douglas Laffoon

Photo 3 — Conditions immediately downriver of cap area (6/13/16):
